DEPARTMENT OF TRANSPORTATION**DIVISION OF ENGINEERING SERVICES**

Contract #: 04-0120F4Cty: SF/ALA Rte: 80 PM: 13.2/13.9File #: 1.28**WELDING INSPECTION REPORT****Resident Engineer:** Casey, William**Address:** 333 Burma Road**City:** Oakland, CA 94607**Report No:** WIR-027404**Date Inspected:** 04-Apr-2012**Project Name:** SAS Superstructure**OSM Arrival Time:** 700**Prime Contractor:** American Bridge/Fluor Enterprises, a JV**OSM Departure Time:** 1730**Contractor:** American Bridge/Fluor Enterprises, a JV**Location:** Job Site

WELDING INSPECTION REPORT

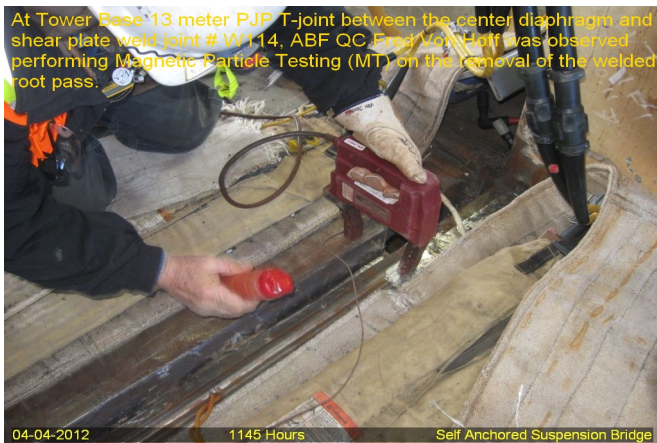
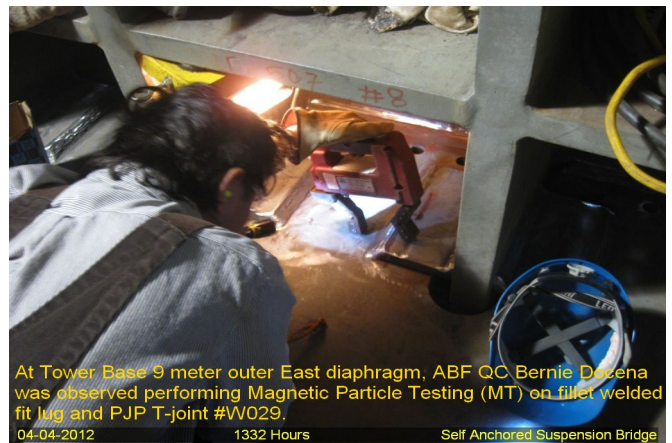
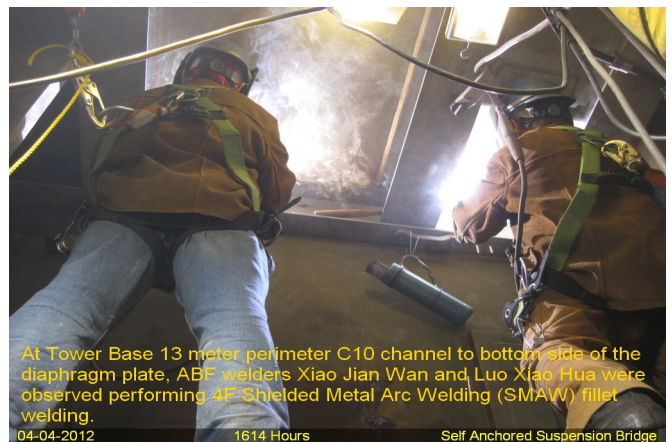
At Tower Base 13 meter center external diaphragm plate to shear plate PJP T-joint W114, this QA has observed ABF welder James Zhen perform 1G (flat position) Shielded Metal Arc Welding (SMAW) welding root pass repair on the PJP T-joint after the entire removal of the previously welded root pass. This repair is being done per Request for Weld Repair (RWR) #201203-005 dated March 29, 2012. The welder was noted using 4.0mm diameter E7018H4R electrode implementing Caltrans approved Welding Procedure Specification (WPS) ABF-WPS-D15-1001 Repair. Prior welding, the joint was preheated using Miller Proheat 35 Induction Heating System with noted temperature of more than 200°F. During welding, ABF QC Fred Von Hoff was noted monitoring the welding parameters with measured working current of 170 amperes. After the completion of the root pass, ABF QC Fred Von Hoff performed the MT on the root pass repair and noted acceptable result. This QA also performed the MT verification and noted same result. After the completion and MT acceptance of the root pass, the welder put more fill passes using the SMAW before the welder used the Submerged Arc Welding. The welding observation was turned over to fellow QA Ken Riley in the afternoon of the shift.

At Tower Base 9 meter North diaphragm, this QA randomly observed ABF welder Wai Kitlai perform 4F (overhead position) Shielded Metal Arc Welding (SMAW) fillet welding the 45mm thick stiffener plate shop marked piece number 439-3 around one foot below the drop in plate ND1-A52. The stiffener is being welded on three sides namely; tower skin plate 'E', North shear plate and vertical stiffener plate. The welder was noted using

At Tower Base 13 meter inner East external diaphragm, this QA Inspector randomly observed ABF personnel Xiao Jian Wan continuing to perform 4F (overhead position) fillet production welding on the perimeter C10 channel to 45mm thick diaphragm plate fillet weld joint W133-2. The welder was noted welding 6mm fillet between one side of the channel top flange and diaphragm plate per detail 1 of the ZPMC drawing number FW3. The welder was using the 3.2mm diameter E7018H4R electrode and implementing Caltrans approved Welding Procedure Specification (WPS) ABF-WPS-D15-F1200A. This QA Inspector observed ABF personnel using propylene gas torch to preheat the plates being welded prior welding. This QA Inspector observed QC Inspector Bernie Docena using a Fluke infra red temperature gauge to verify the preheat temperature of more than 150°F. This QA Inspector performed a verification of the welding parameters and observed 120 amperes on the 3.2mm diameter electrode. The welding appeared to comply with Welding Procedure Specification (WPS) ABF-WPS-F1200A. At the end of the shift, SMAW fillet welding was completed.

1. W050 9M diaphragm PJP T-joint – weld cover QA verified
2. W050 9M diaphragm PJP T-joint – weld cover QA verified
3. W132-1 13M diaphragm fillet weld joint - weld cover QA verified
4. W133-1 13M diaphragm fillet weld joint - weld cover QA verified
5. W091-19 to W091-36 fit lug fillet weld joints - weld cover QA verified
6. W029 9M diaphragm PJP T-joint – weld cover QA verified
